PATRICK LAKE WATERSHED MANAGEMENT PLAN

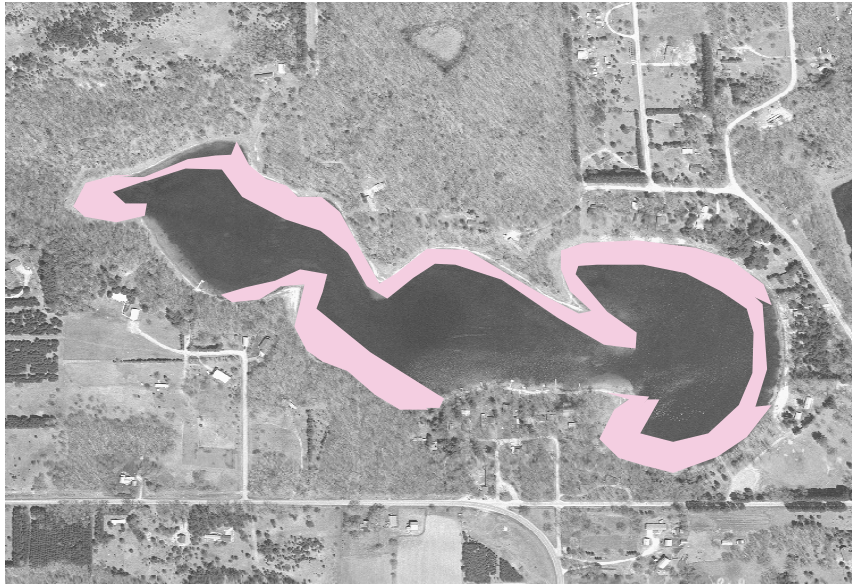
Floating-Leaf Plants in Patrick Lake

Overall, 3 of the species found were emergent species, 3 were floating-leaf and 12 were submergent. The latter includes Eurasian watermilfoil (*Myriophyllum spicatum*). Filamentous algae was found at 36% of the sample sites.
